GREAT NEAPOLITAN EARTHQUAKE OF 1857.

OBSERVATIONAL SEISMOLOGY

TO INVESTIGATE THE CIRCUMSTANCES OF THE GREAT
EARTHQUAKE OF DECEMBER 1857.

ROBERT MALLET, C.E., F.R.S., F.G.S., M.R.I.A.,
&c., &c.

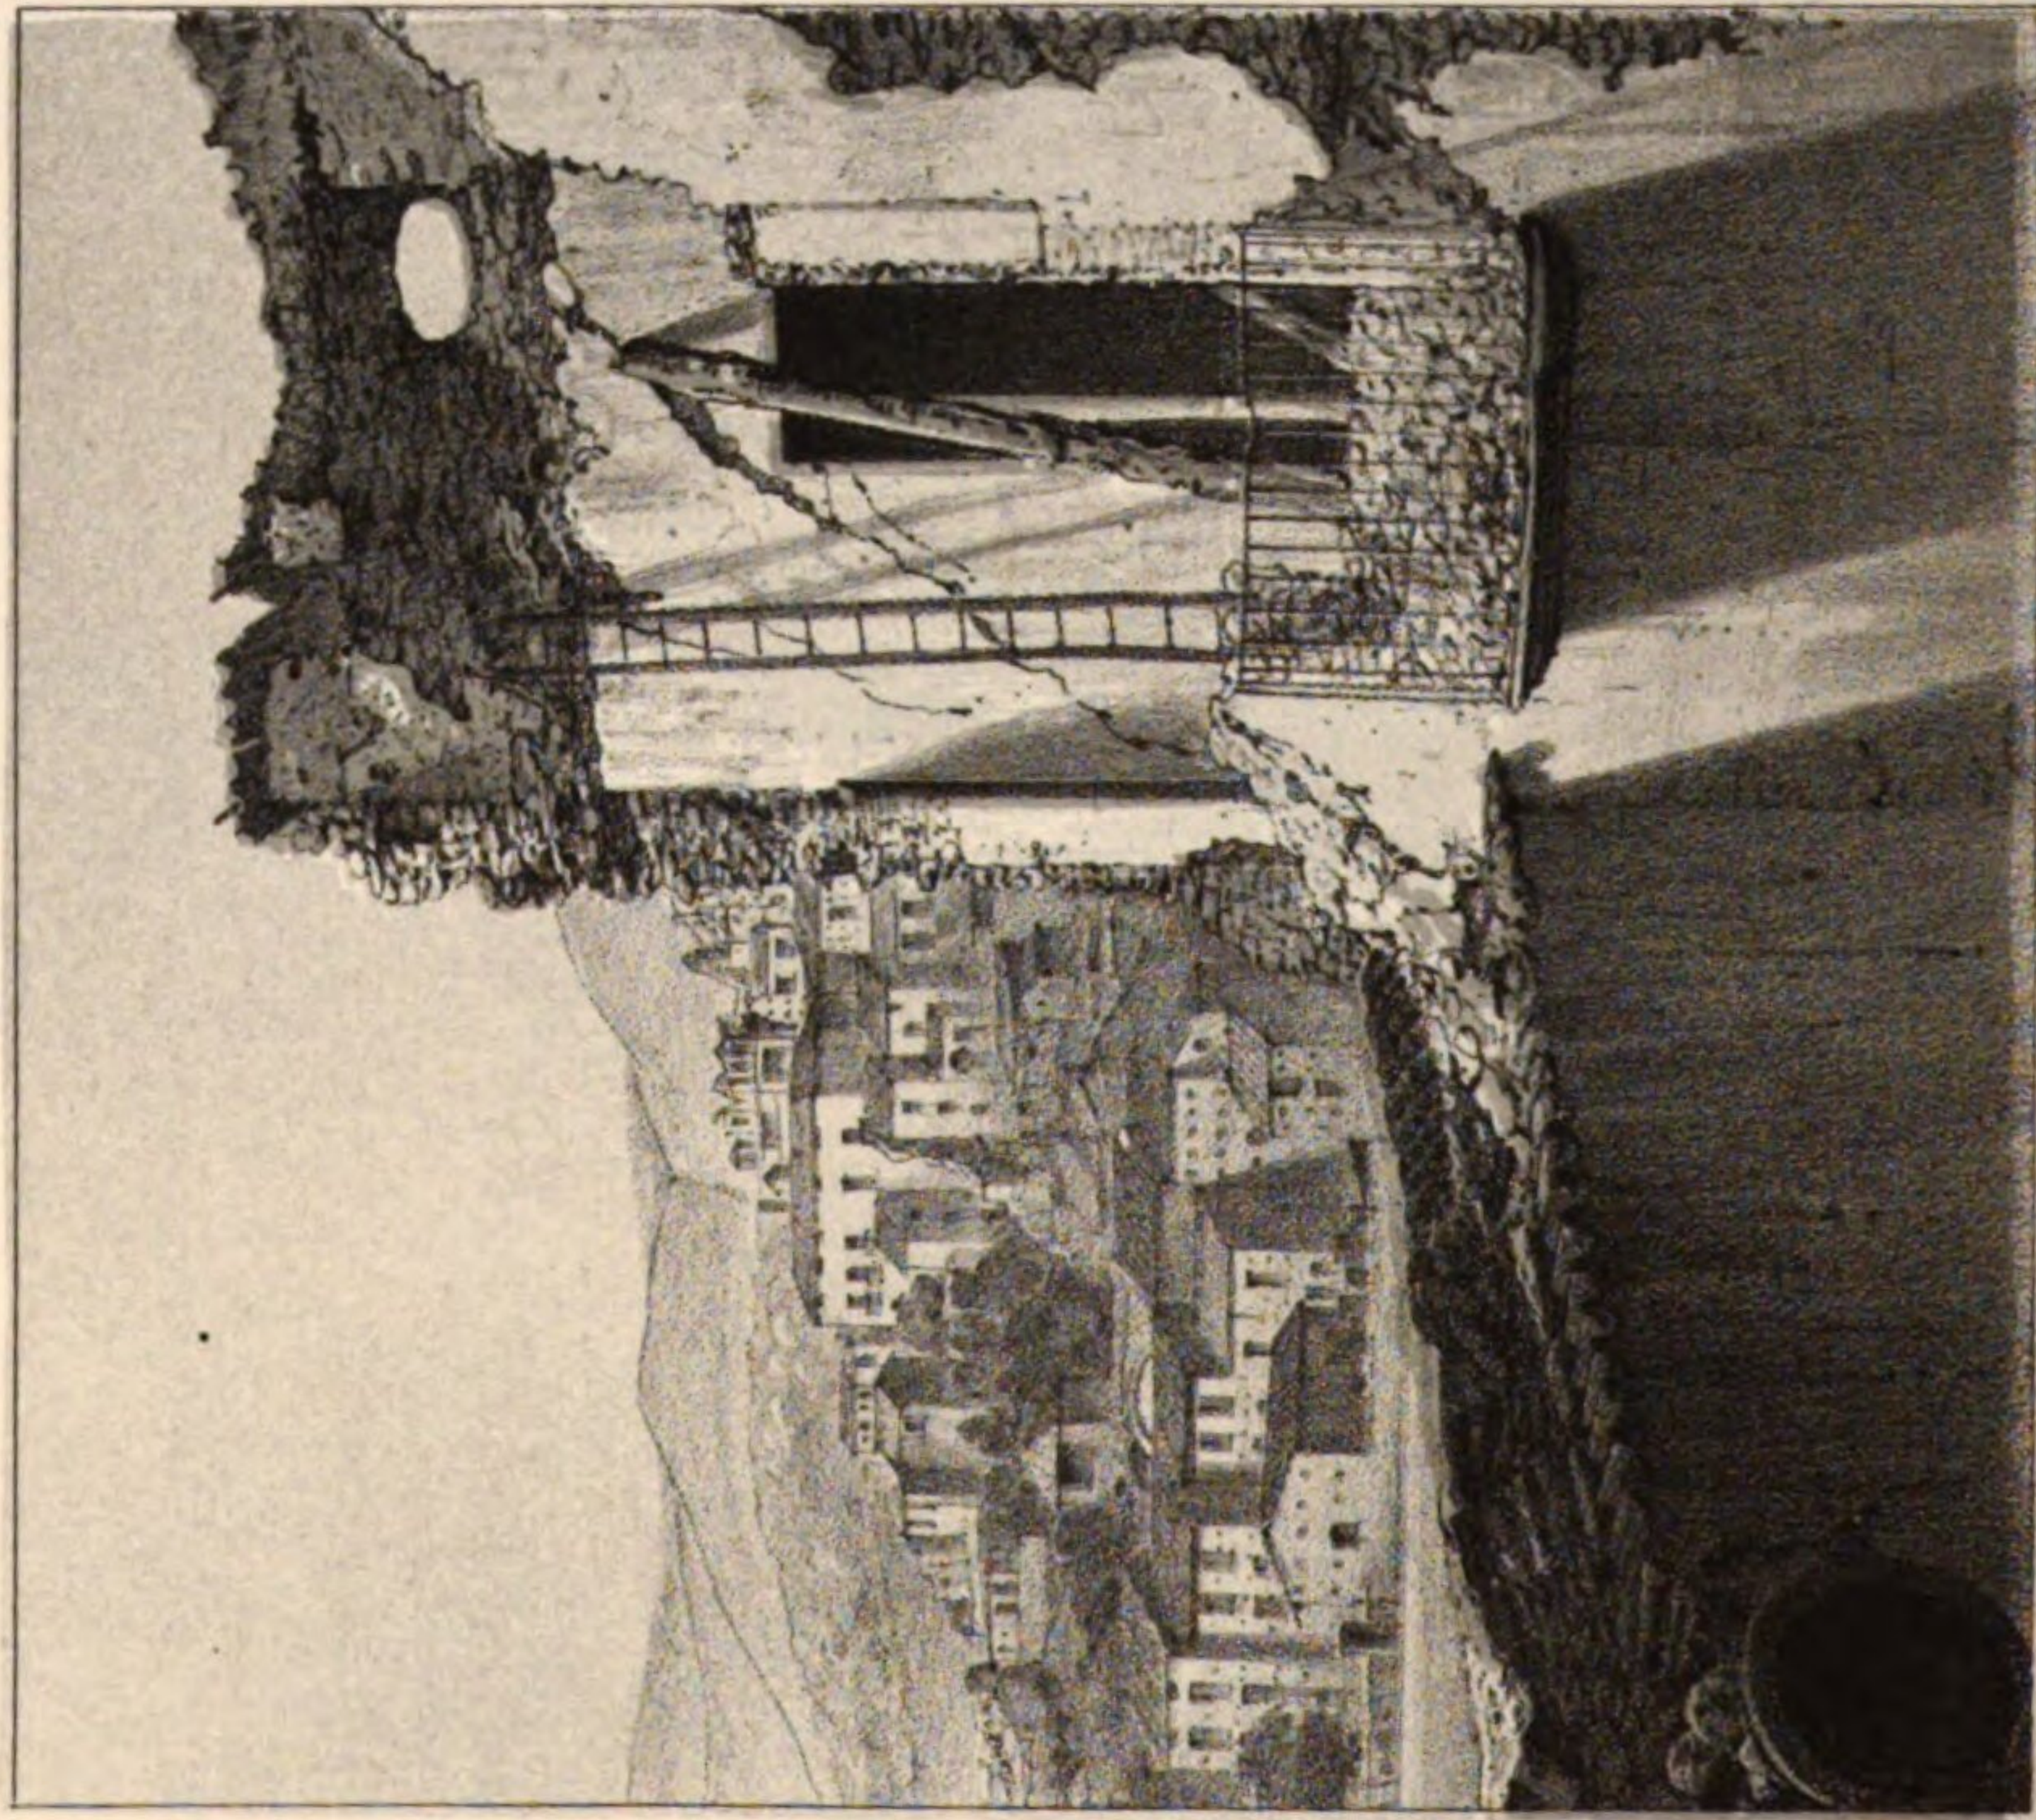
INTERIOR COURT, PALAZZO PALMIERI, POLLA.

This is shown, in part, in Photog. No. 180 (Coll. Roy. Soc.), as seen from the balcony of the staircase, directly opposite the entrance gateway, and is shown in elevation in Photog. No. 179, looking eastward. In all these the general directions and angles of the fissures are correctly exhibited. There are some fissures, in all the walls, but the great mass are in those running north and south.

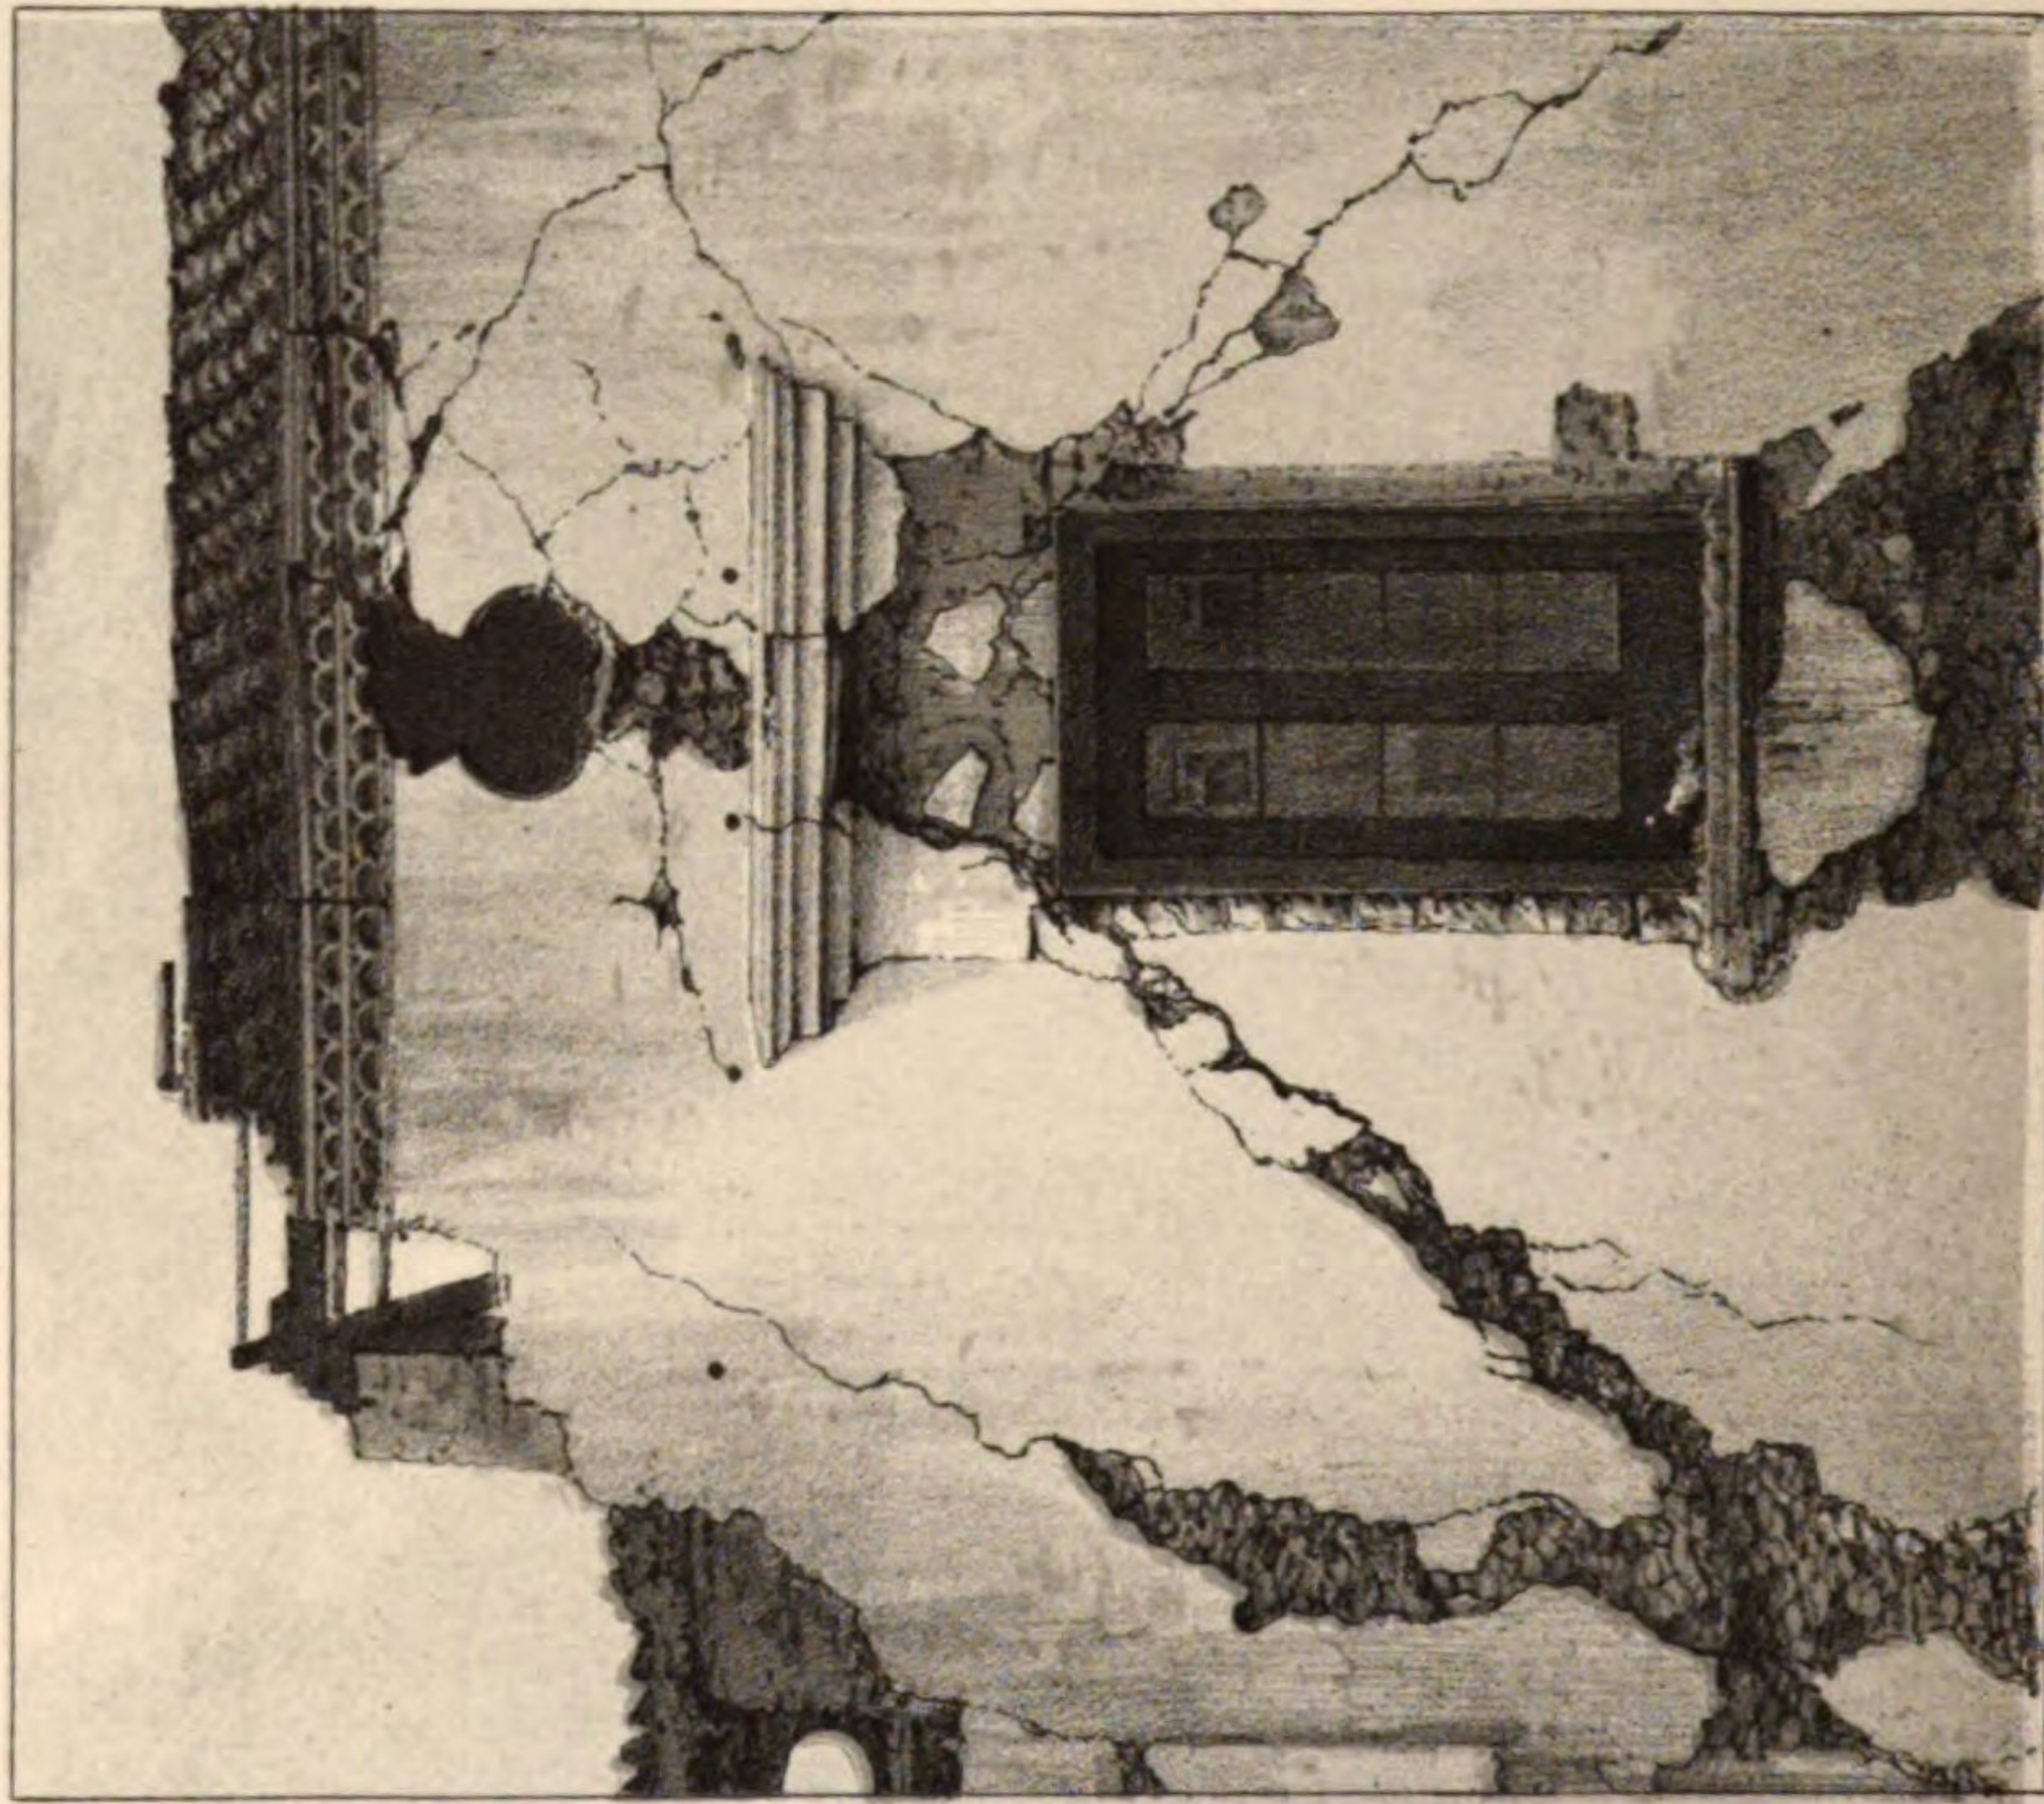
INTERIOR FACADE, PALAZZO PALMIERI, POLLA,
Looking Westward.

The Palazzo Palmieri is fissured diagonally in every wall more or less, those in the north and south walls being the most formidable. A large wedge-shaped mass, carrying with it a portion of the roof, is thrown from the S.W. quoin of the front, and a large portion of the south external wall, is prostrate and thrown to the south.

we find $\tan e = 1.593$, and $e = 57^\circ 50'$, an angle of emergence which is within the limits given, by the fissures (which in this instance are extremely well defined in the Photogs. Nos. 177, 179, and 180, Coll. Roy. Soc.) in several parts of this building, and in that of the sluice-house at the river close by.

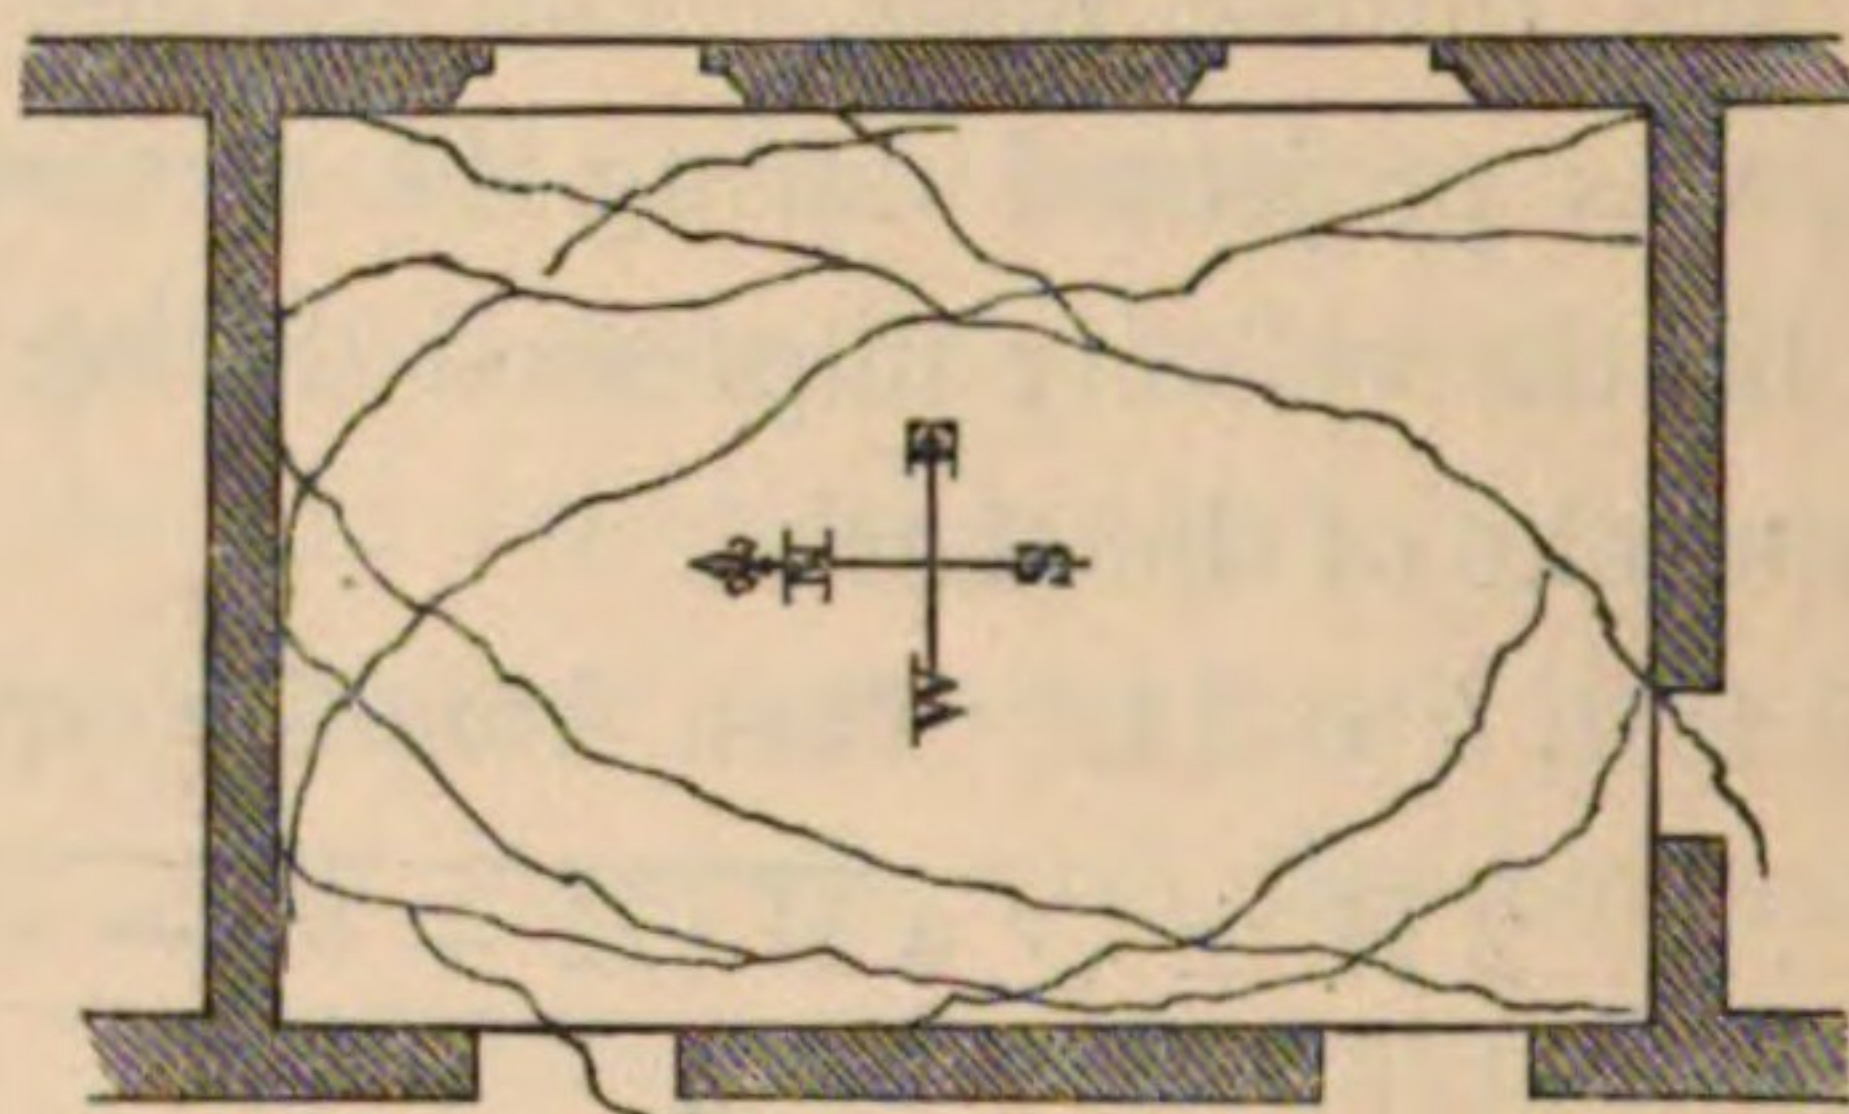
Throughout the Palazzo, the floors are of beton and tiles, laid upon thick oak planking, crossing over oak and fir joists at about three feet apart: some in the largest rooms at the north wing, have been brought down altogether, the fractured beams showing, that they yielded to the inertia of the mass of beton and tiles, under the emergent wave. All are fissured, in various directions diagonally across, the lines more or less curved, with the *hollow sides of the curves towards the centre* of the floor, and upon the whole making angles of about $22^\circ 30'$ with their respective walls, and crossing each other towards the mid length, nearly at right angles; the great prevailing direction $22^\circ 30'$ E. of north, and at right angles to the same. These floor fissures, as nearly as they could be drawn by the eye,

in one of the large reception rooms of the first floor, are shown in Fig. 181.

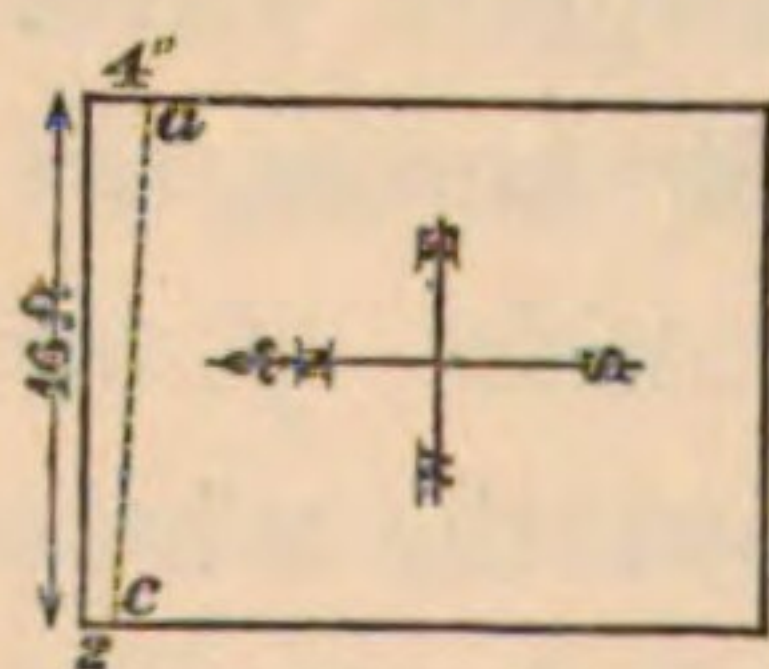
Fig. 182.

In the great drawing-room, the diagonal fissures in the north and south walls are 2, $2\frac{1}{2}$, and 3 inches wide at the ceiling level, in about 16 feet in height. And the brown planks of the naked floor above, (naked here, because all the ceiling has come down, and left the oak and chestnut bare) have drawn from the north wall, which has gone out, and the floor and south wall have gone together in the opposite direction, the total movement at the floor level being $4\frac{1}{2}$ inches, and almost exactly parallel to the line of the east and west walls. In another room, of 16 feet in length of end wall, the planking has drawn from the north end wall, 4 inches at the east, and but 2 inches at the west corner,

indicating a wave-path north and south, with some degrees trend to the east of north. The east and west walls being heavily fissured, the south wall had gone out in the direction parallel to ac (Fig. 182).

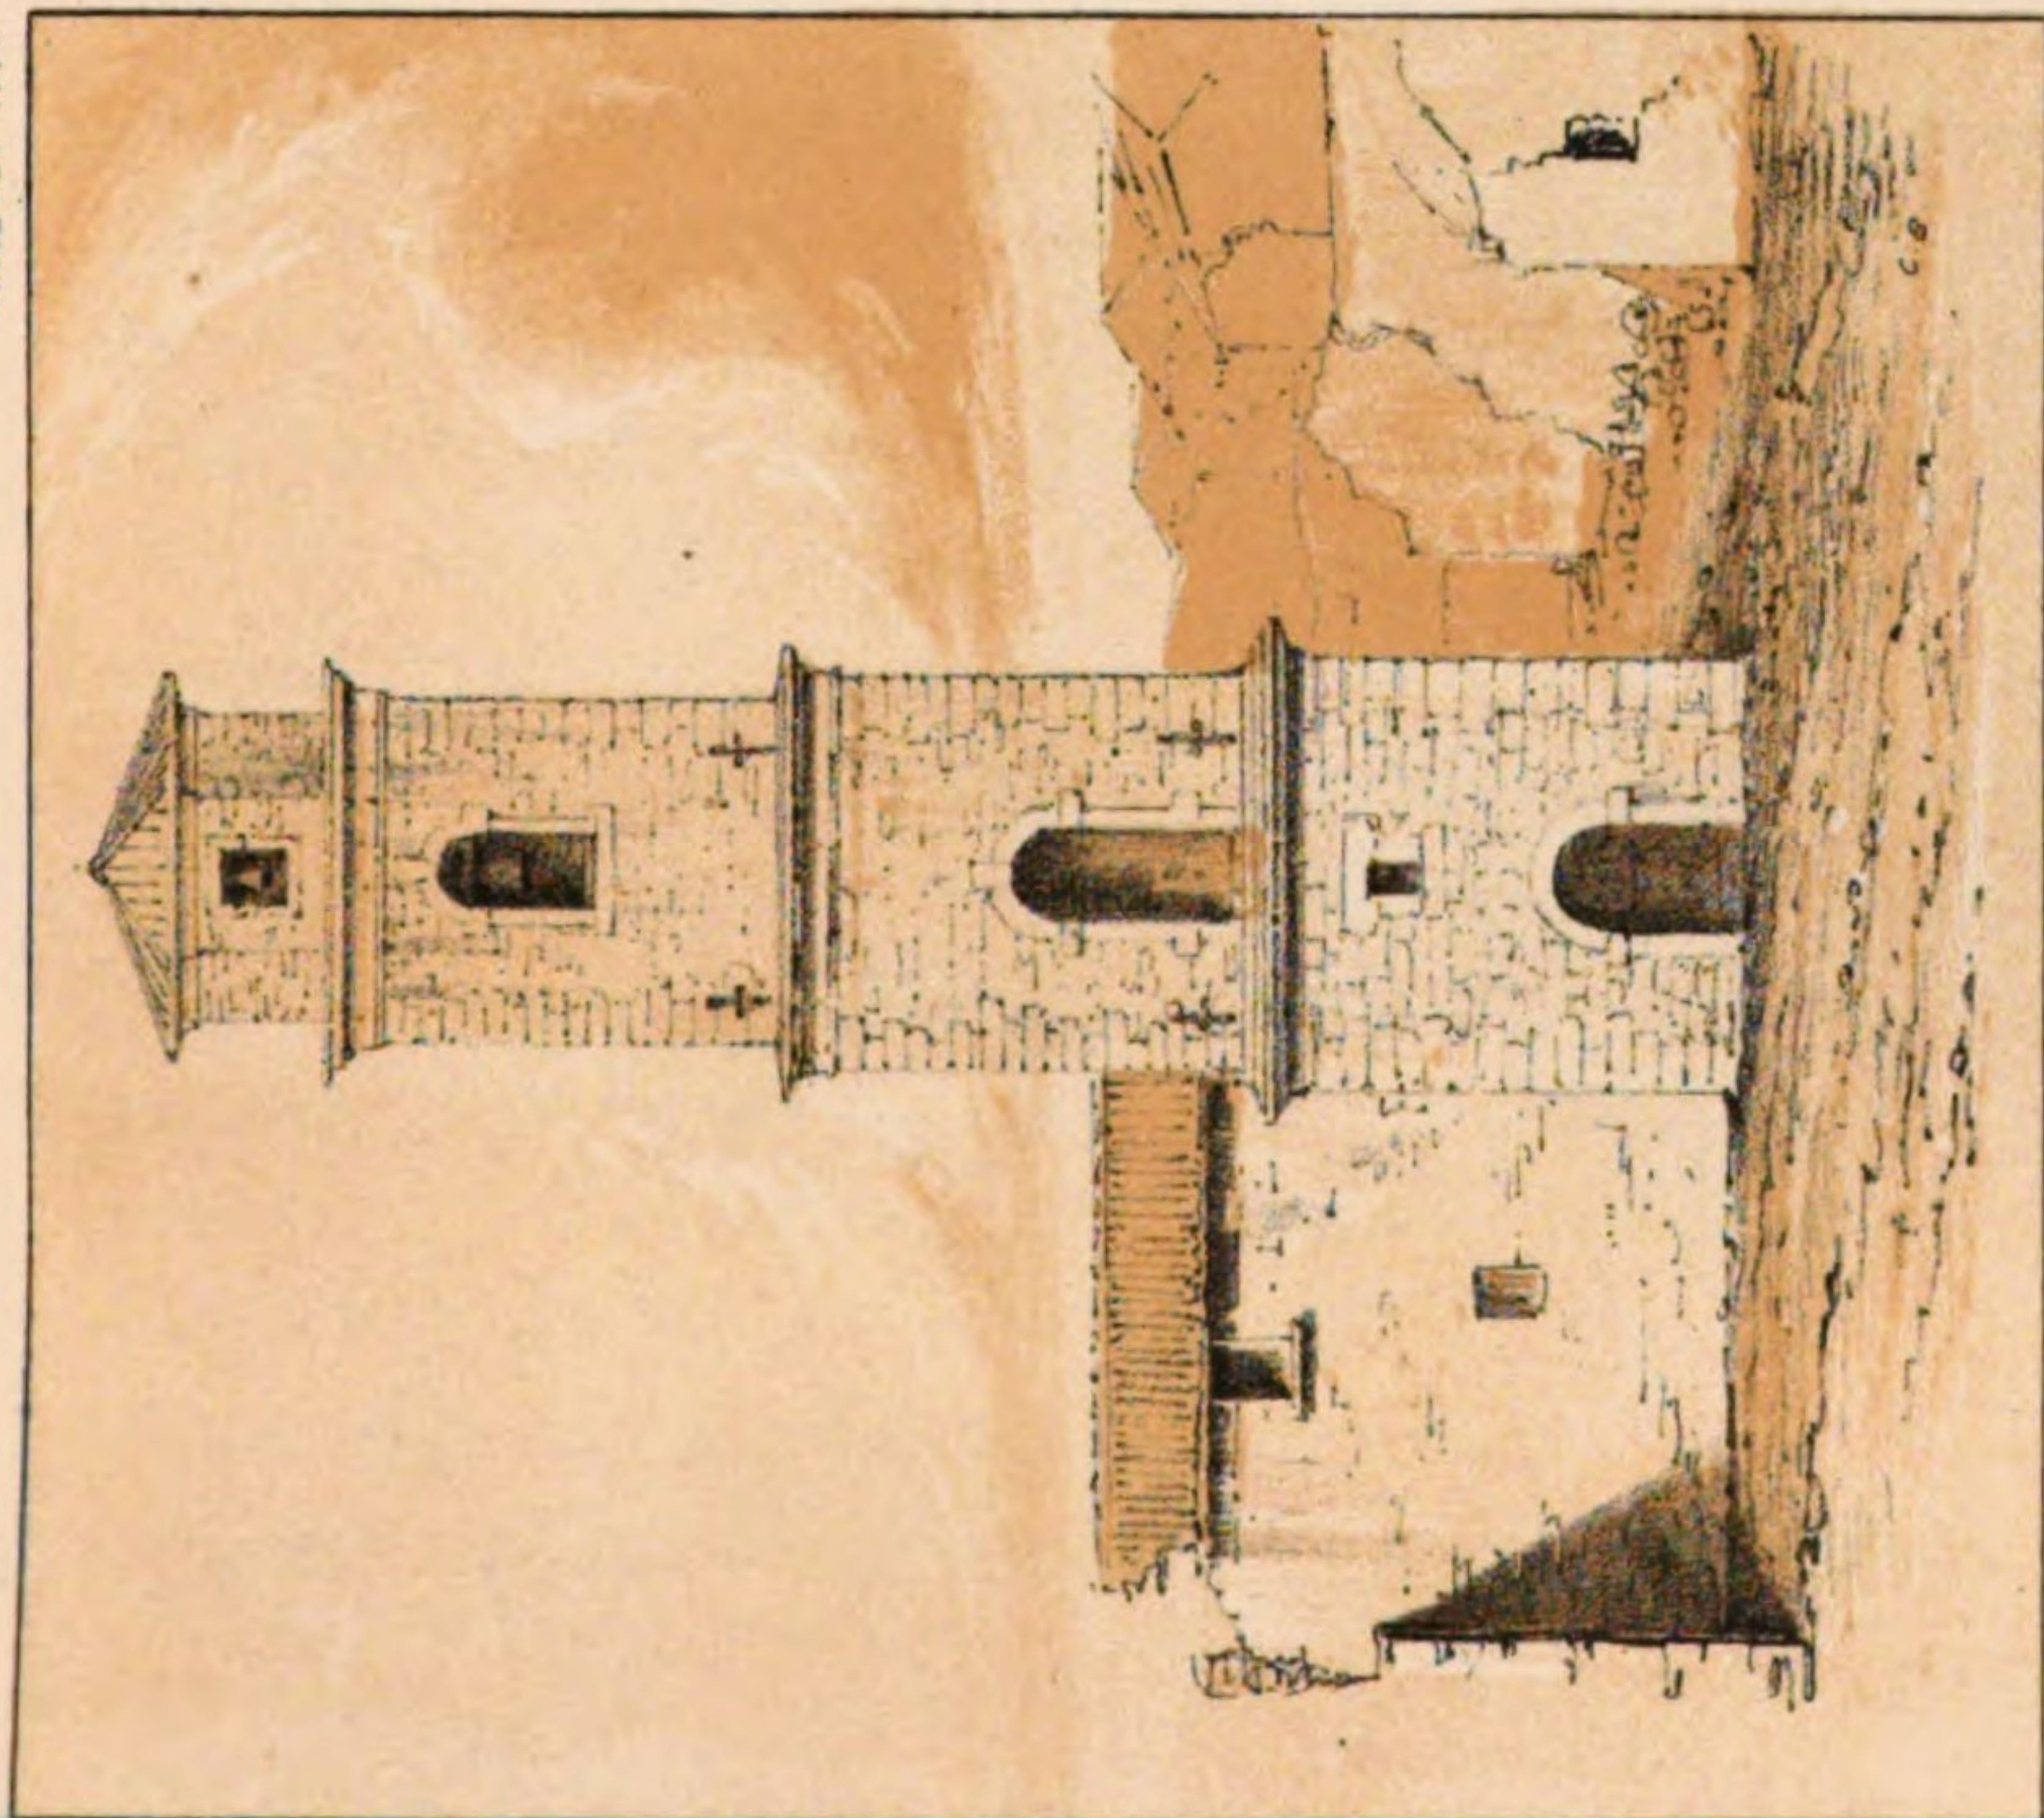
The Photog. No. 189 (Coll. Roy. Soc.) shows the east end of the cathedral church, and various adjoining buildings, looking nearly westward. The general evidence of the wave-path with steep emergence from the north, is observable in the thrown and shattered north and south walls, and in the wedge-like mass, projected from the S. E. quoin of

the chancel, and the roof of it and of the south transept fallen *inwards*. The horizontal direction of wave-path deduced from the thrown quoin, and from the average of five sets of fissures in the church, was $165^{\circ} 30'$ E. of north, and the angle of emergence $47^{\circ} 30'$. The angle of emergence given by thrown quoins in three other buildings (dwelling-houses), of much worse masonry, however, and therefore capable of less exact determination, was only $39^{\circ} 30'$. Lower down upon the eastern slope of the town a large heavily built range of building, with front walls to the narrow street $3\frac{1}{2}$ feet in thickness, running nearly east and west, shows fissures of two inches wide, on the level of the first floor above ground, which indicate a wave-path not far from north and south, $177^{\circ} 50'$ E., the nearest approximation. One of these in the soffit of the arch, over a "portone" leading to a "vicinello" is shown in Sketch Fig. 190, and gave a path exactly north to south. A wall of old and little coherent masonry, has had six feet in height of its upper part thrown off, parting horizontally along, at 38 feet from the base. The mass of material has fallen at an average distance of 20 feet from the base, towards the south, and a point or two towards the west. The angle of emergence deduced from this (the horizontal velocity as at Polla) is between 45° and 50° , dependent upon the constant adopted for the adherence of the mortar and masonry at the base of separation. The result sufficiently corroborates those above given from more certain data.

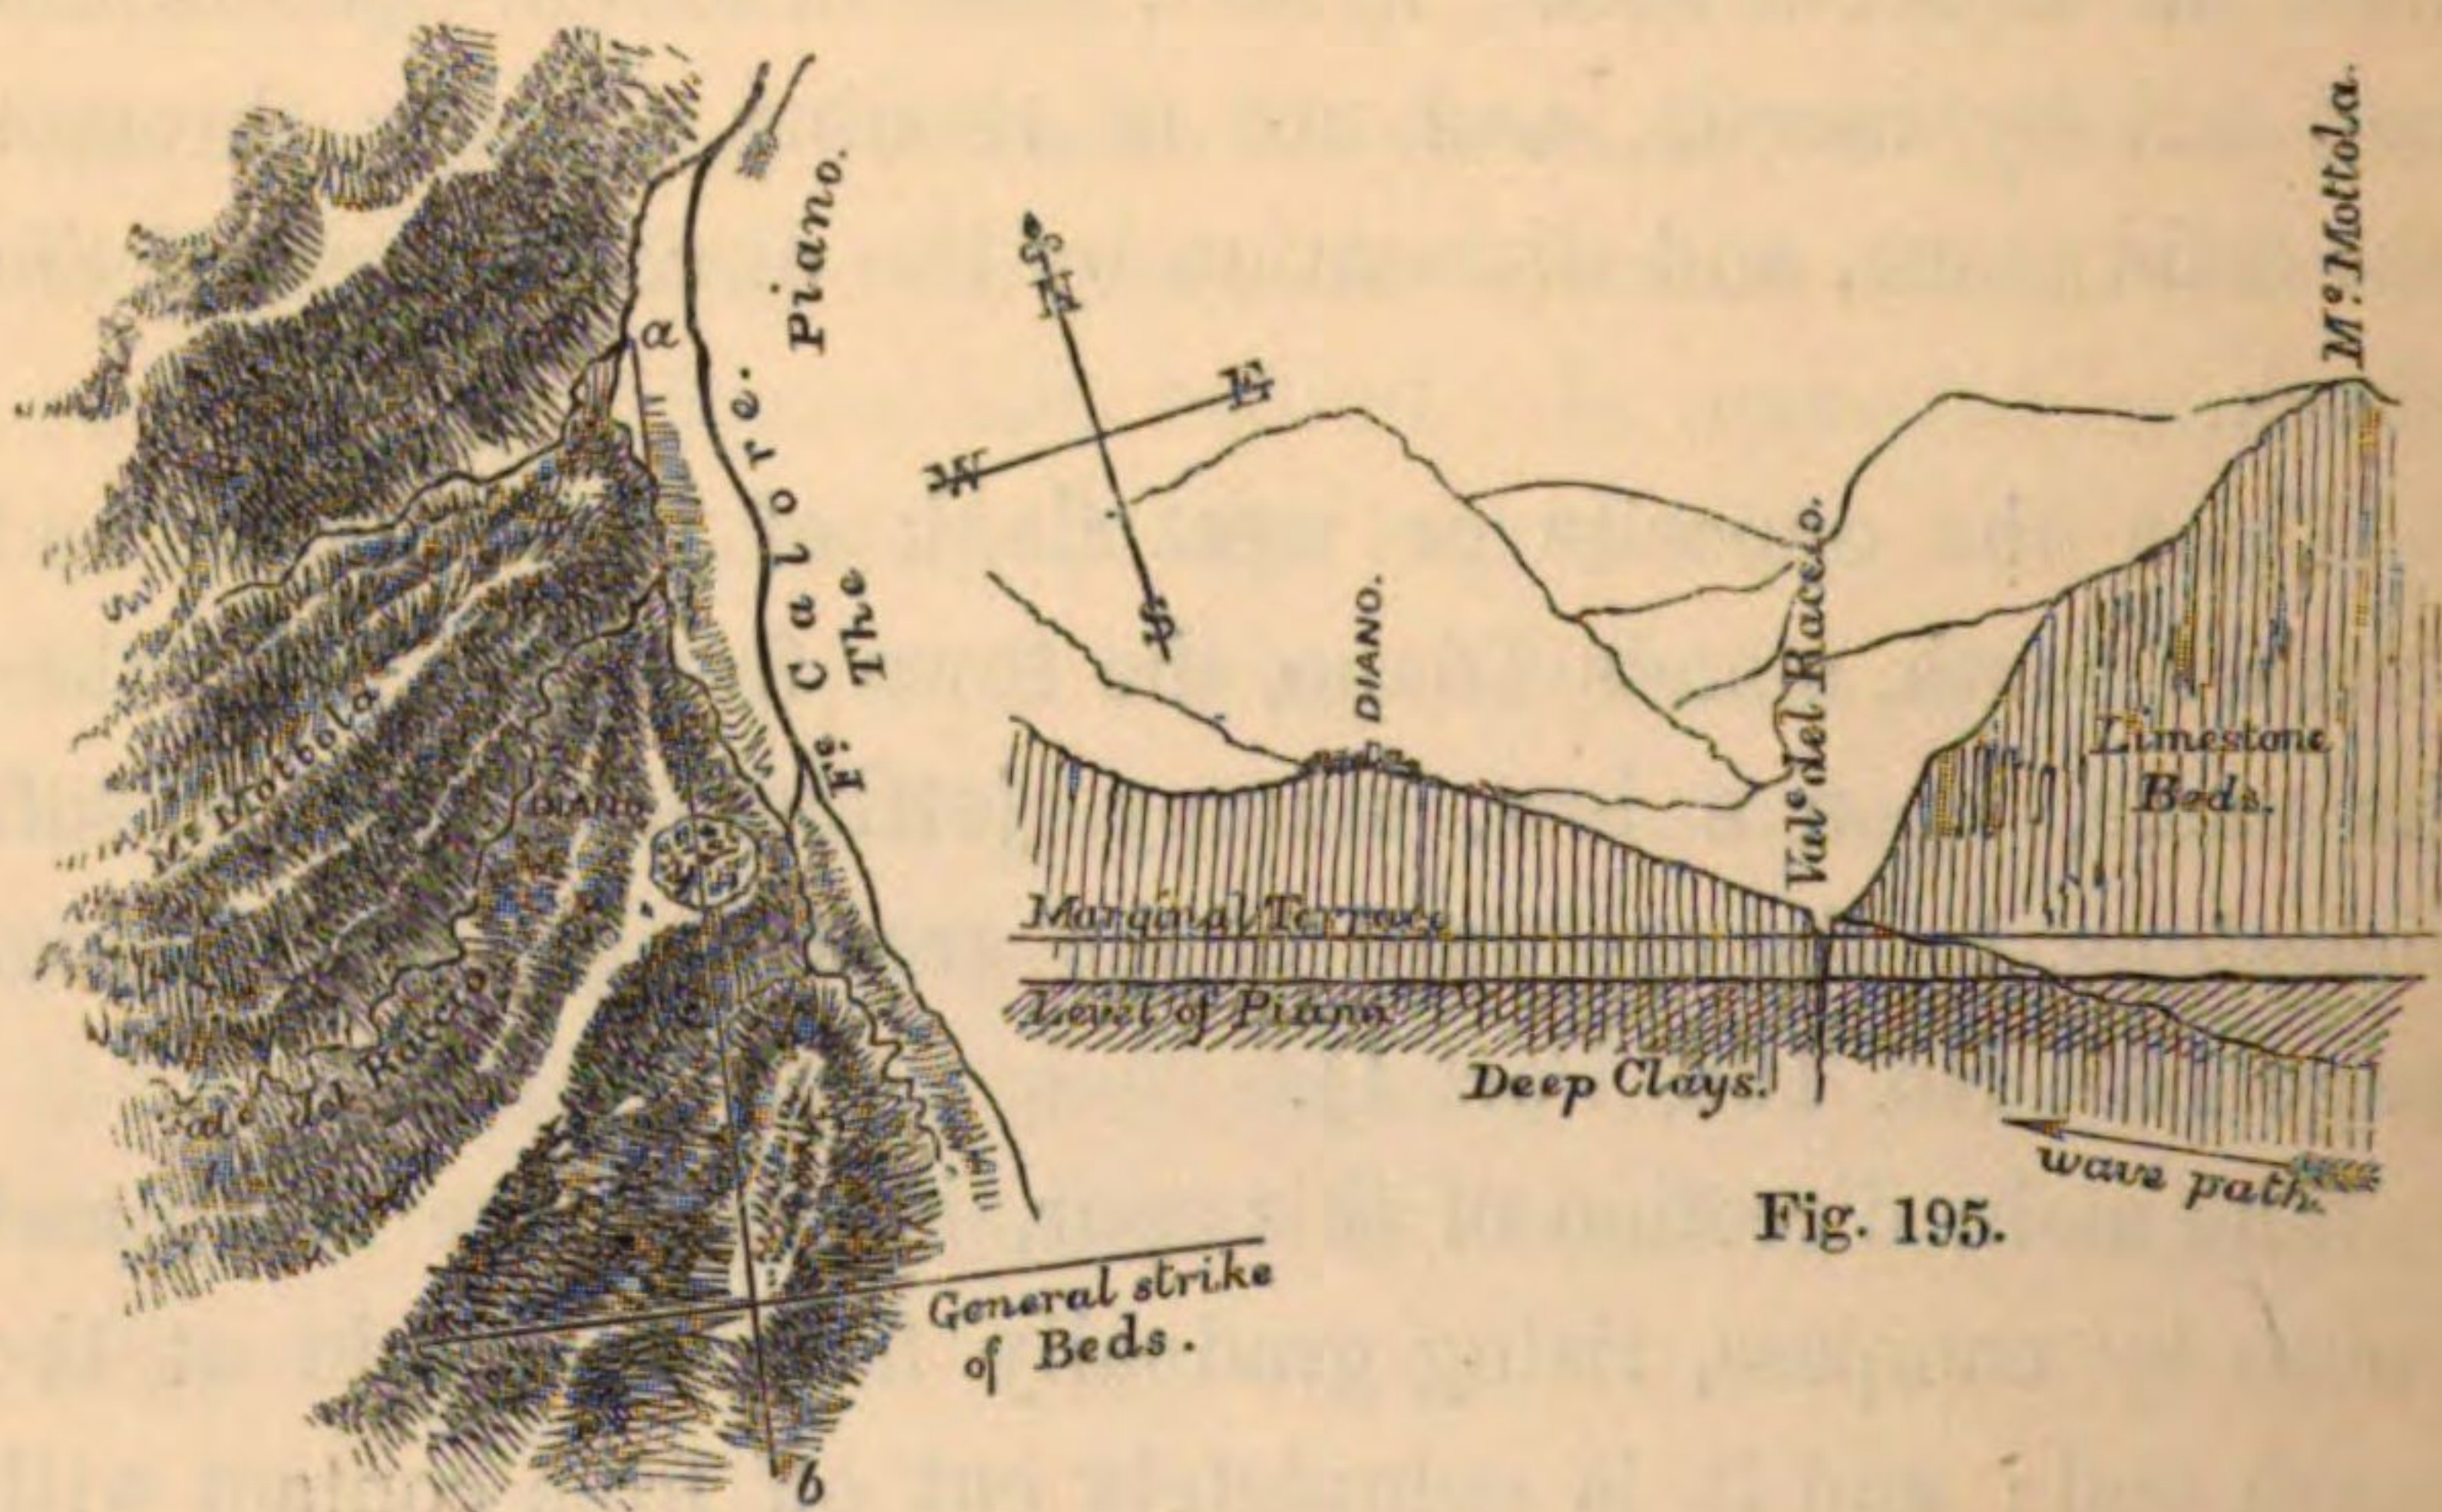
The comparative immunity from destruction of Diano, is not difficult to explain. The direction of wave-path was here nearly due north to south. It therefore passed from the deep clays of the piano into the long spur or colline of the town, end on, (see Sketch Nos. 194, 195,) losing a large portion of

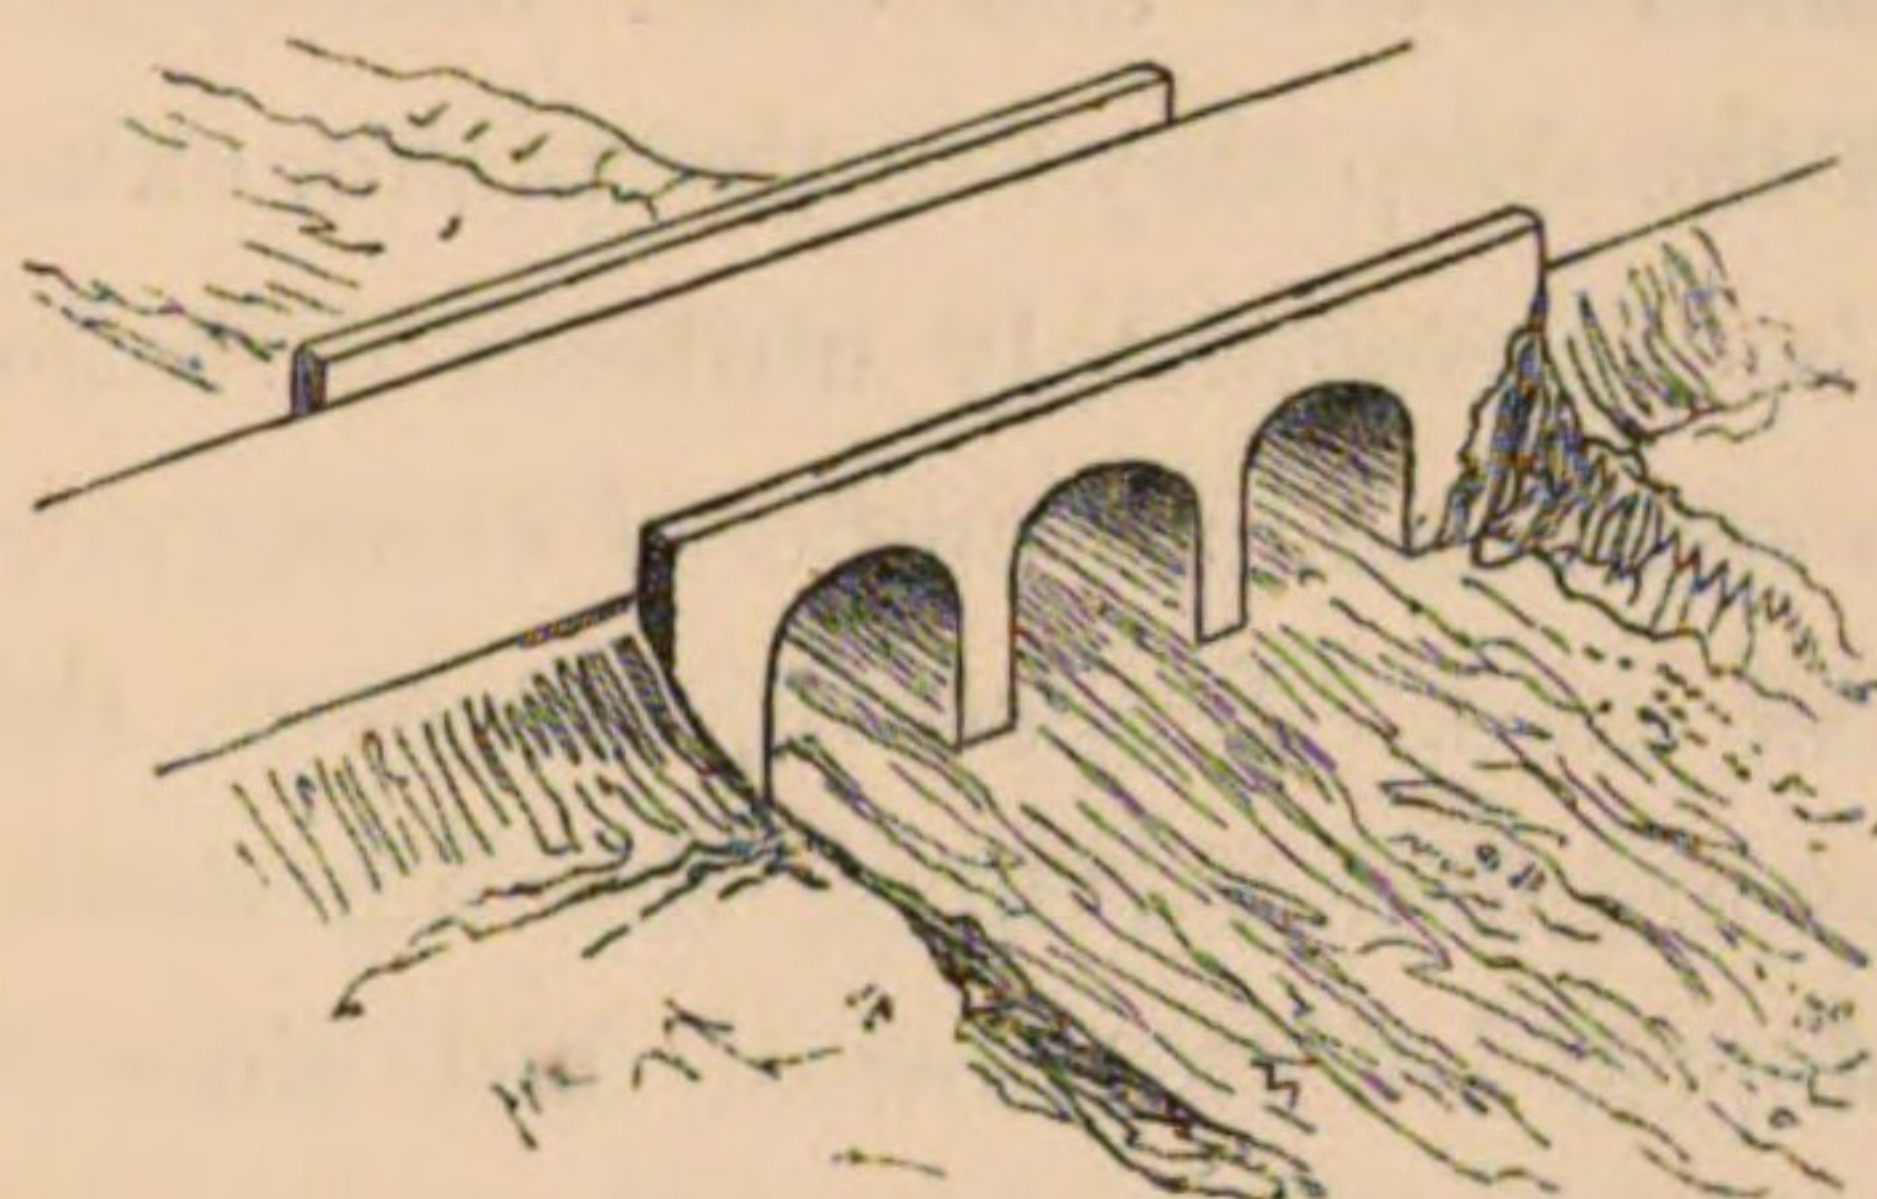
Fig. 196.

The structure was not overloaded with material and was well put together, and the mortar still green. It did not exhibit a trace of injury. (See Fig. 196.)
